REGIONAL DISTRICT OF NORTH OKANAGAN

CIVIC ARENA ENGINEERING ASSESSMENT

FINAL REPORT

Revised to 4 March 2014

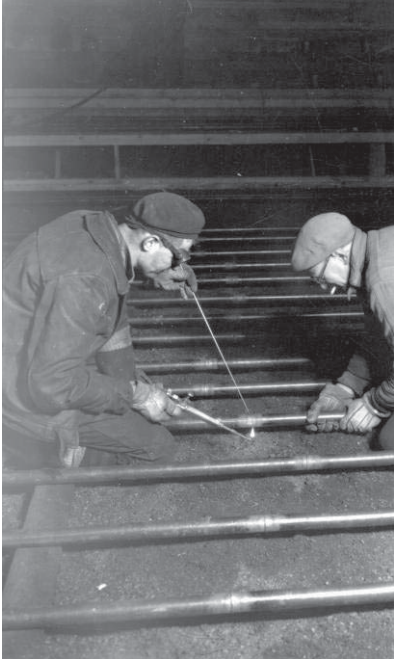
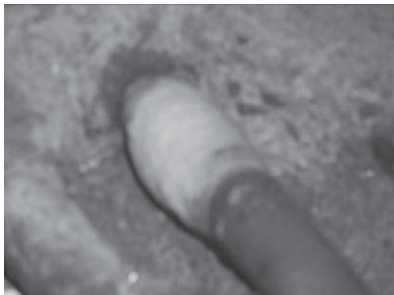
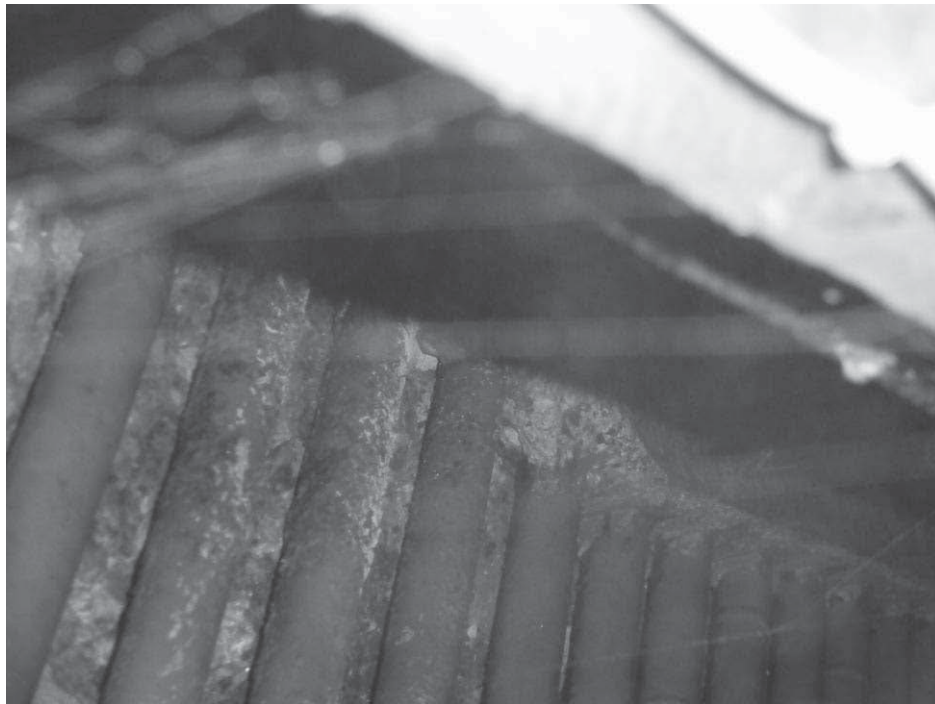
Above:
Historical photo of the refrigeration
piping being welded in situ
Below and right:
Refrigeration pipe during a recent
repair

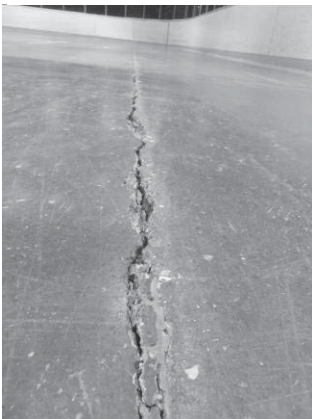
Below: Cracked ice slab today

- ★ The ice slab and its component parts are recommended to be replaced

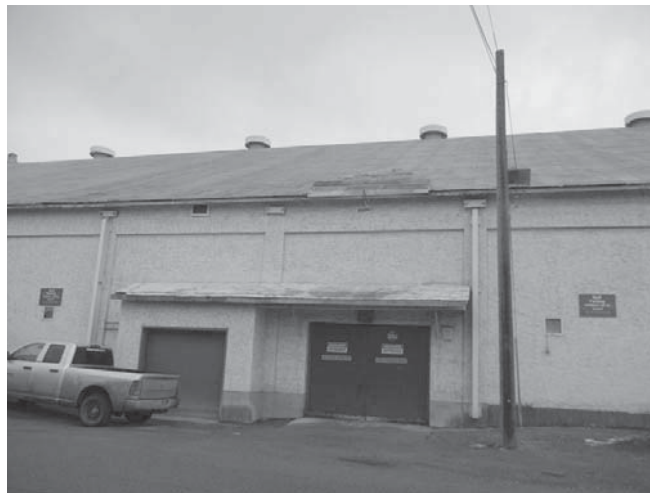
The metal material on top of the roof has yet to be replaced with a slippery surface material. This is a concern due to the roof being unable to shed snow as assumed in the design and construction upgrades to the roof.

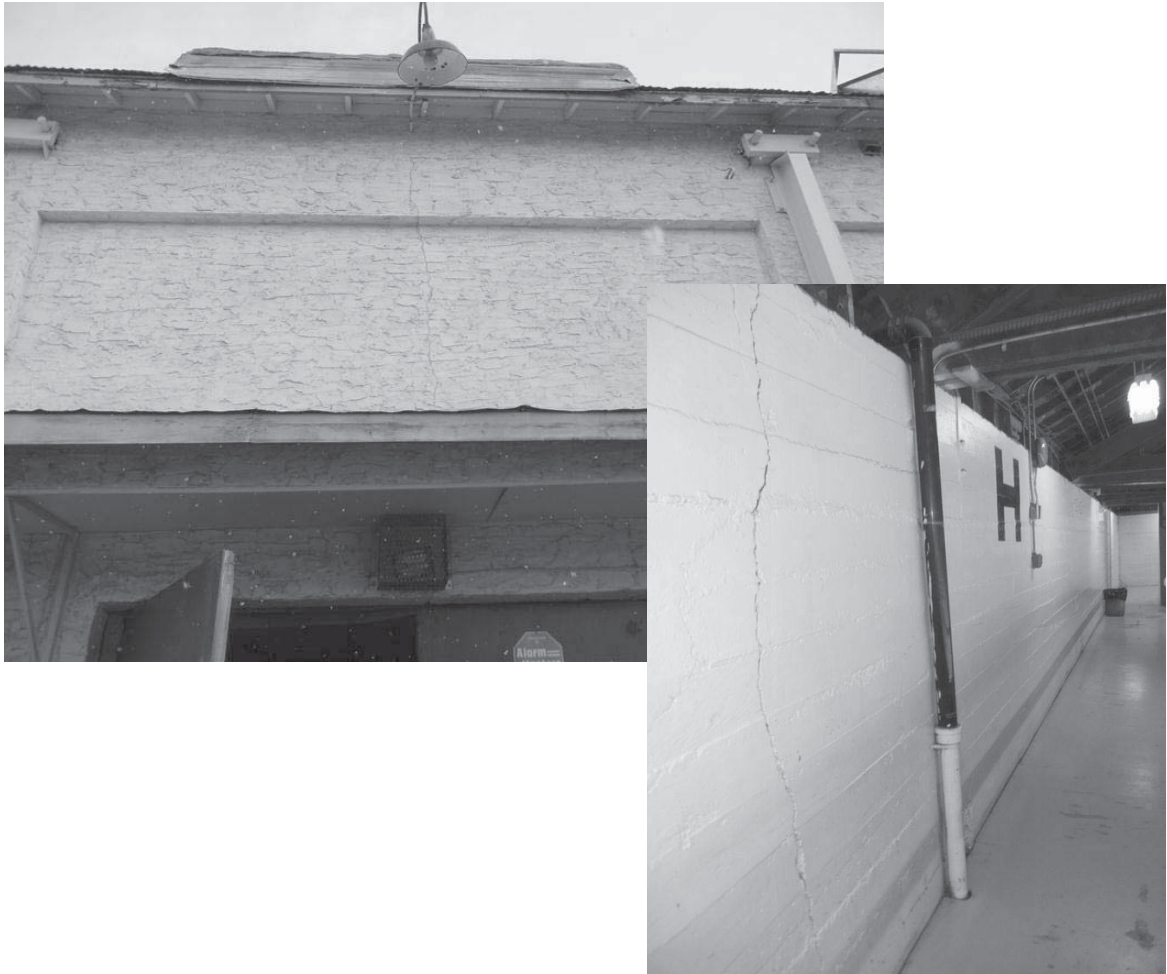
A number of cracks were visible in the perimeter concrete walls of the arena. Some are very small shrinkage cracks while others are a little wider. These occur at various points along the building perimeter and are not concentrated in the regions of maximum heave of the ice rink slab. No significant concrete spalling or corrosion are visible in these locations although these can be seen from both the interior and exterior of the building.

★ Cracks in concrete should be filled to prevent freeze thaw damage. The stucco cladding is in generally poor condition and is less than pleasing in today's context. Repairs or removal might be considered.

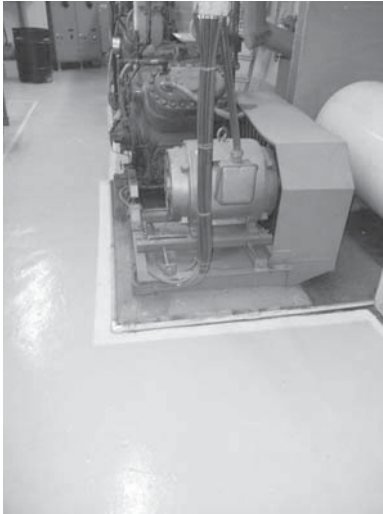
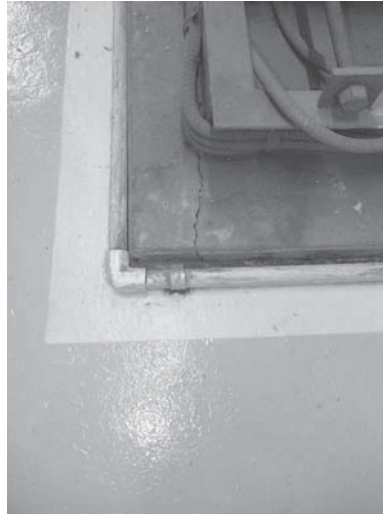
The slab on grade in the remainder of the building appears to be in good condition. Although some minor cracking is visible in some of the equipment housekeeping pads

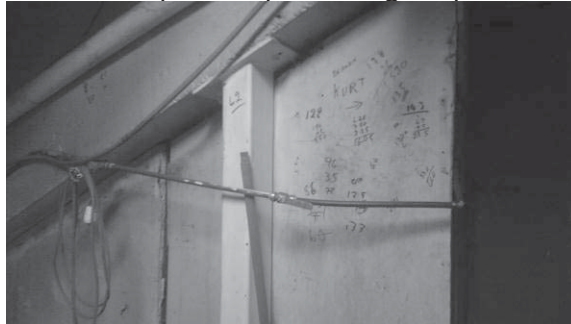
- Open combustion gas fired equipment is very inefficient.
- Insulation is missing or in poor repair throughout
- General repair of plumbing required

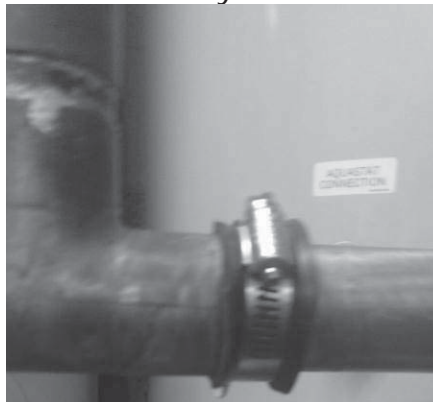
- Leak on hot water system

- ★ Plumbing leaks on domestic hot water side, fixture replacement are immediate priorities.

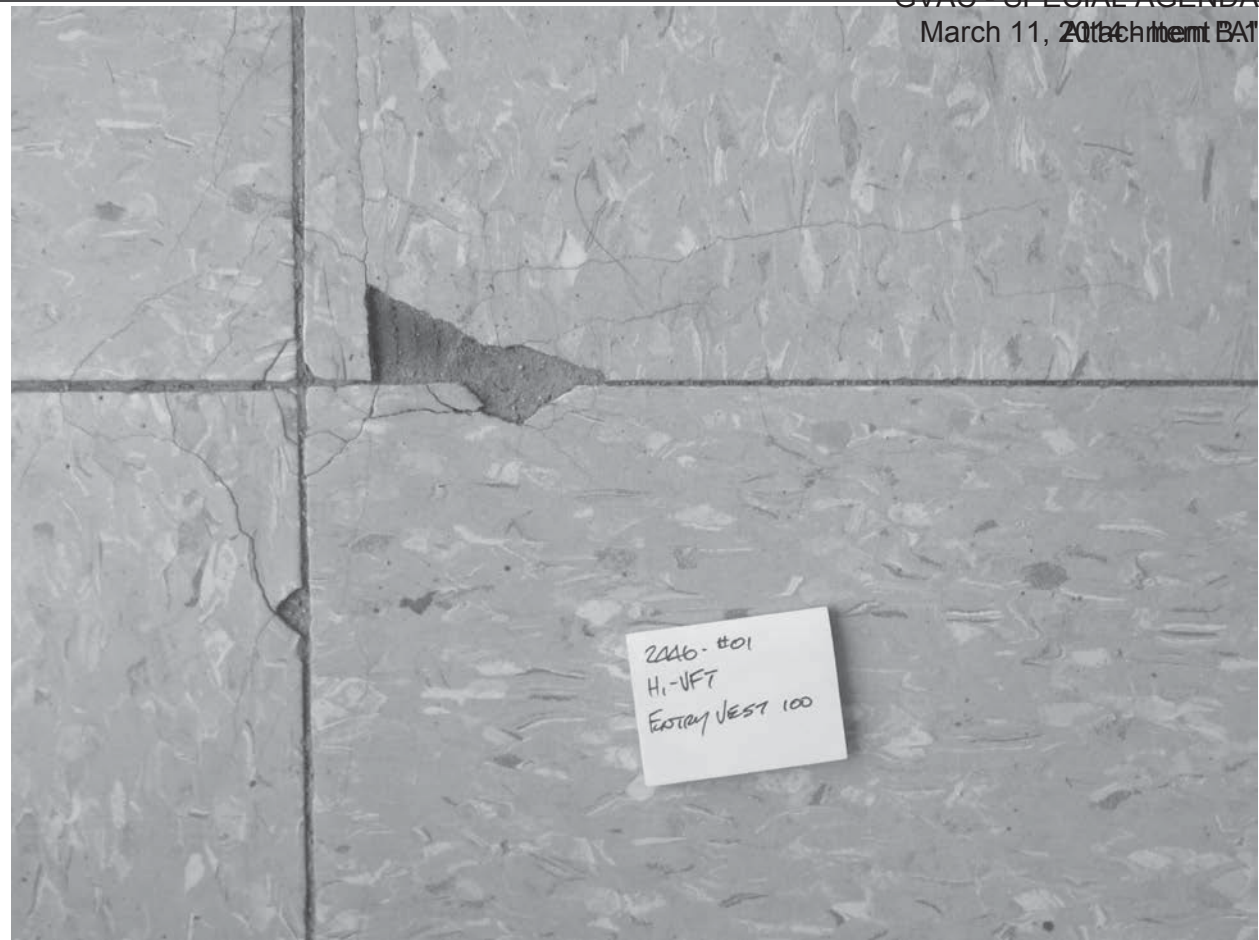
Picture No. 1: Sample 1 – (H1) Asbestos Floor Tile

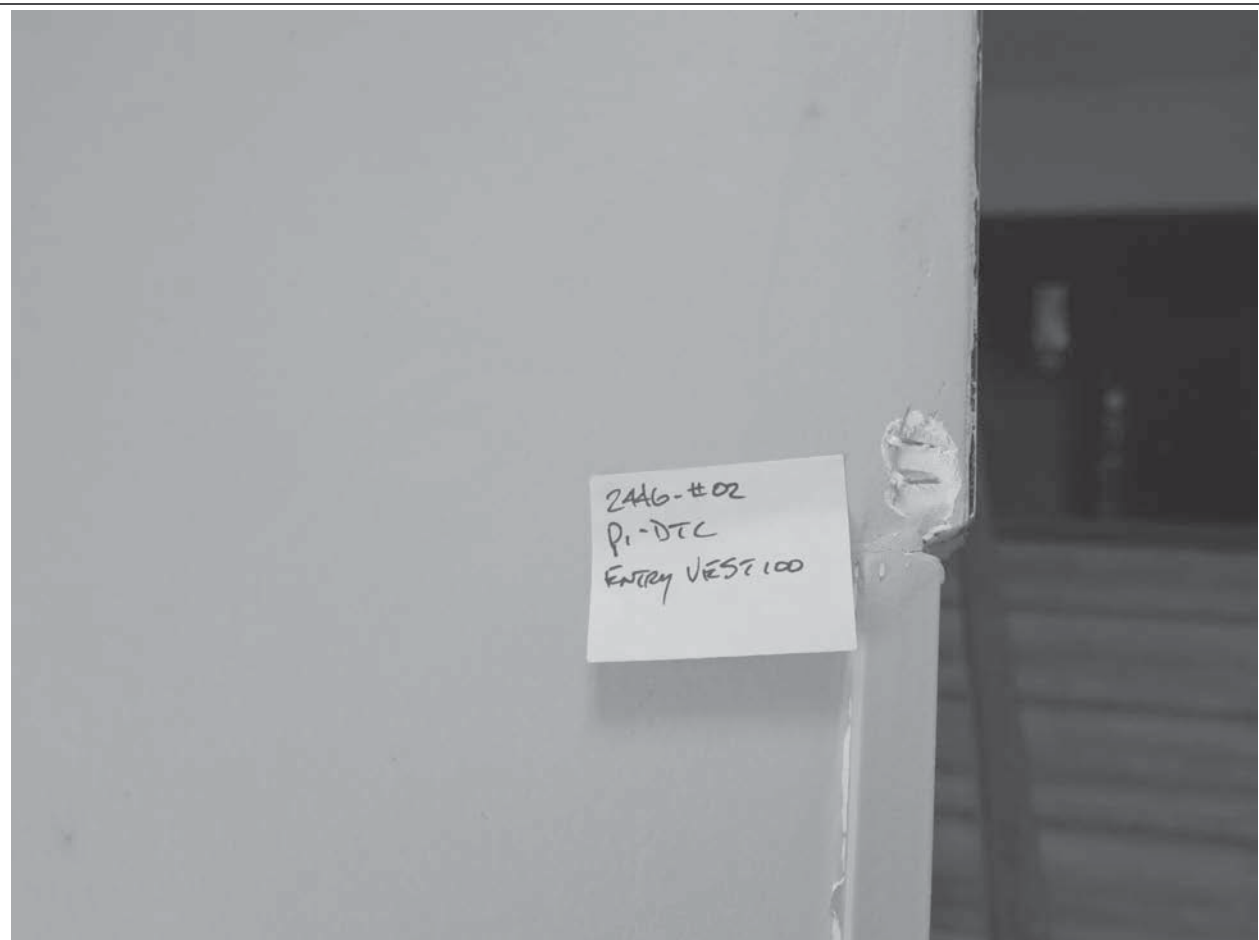
Picture No. 2: Sample 2 – (P1) Asbestos Drywall Tape Compound (typical)

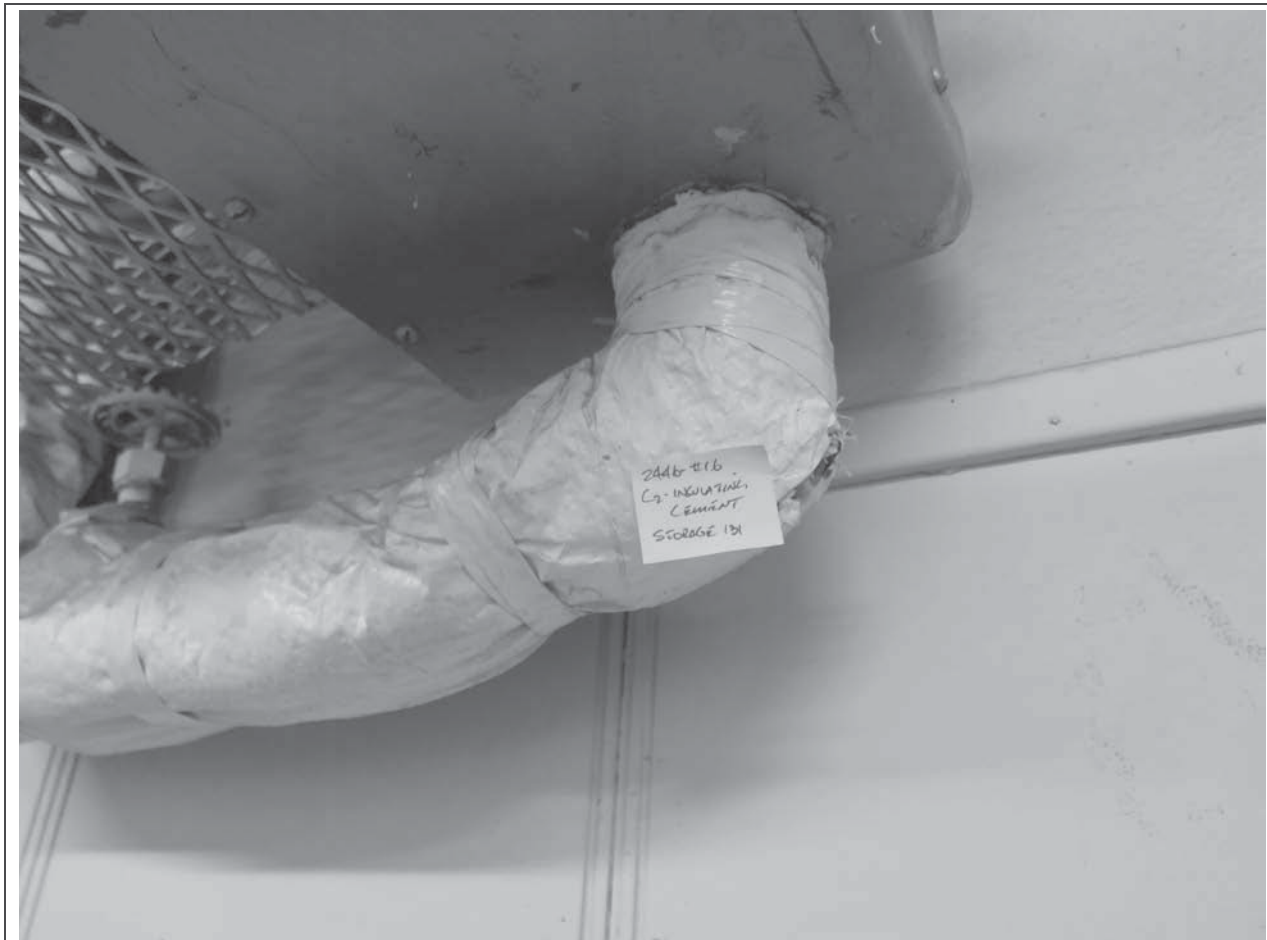
Picture No. 15: Poor Condition Asbestos Insulating Cement (typical)

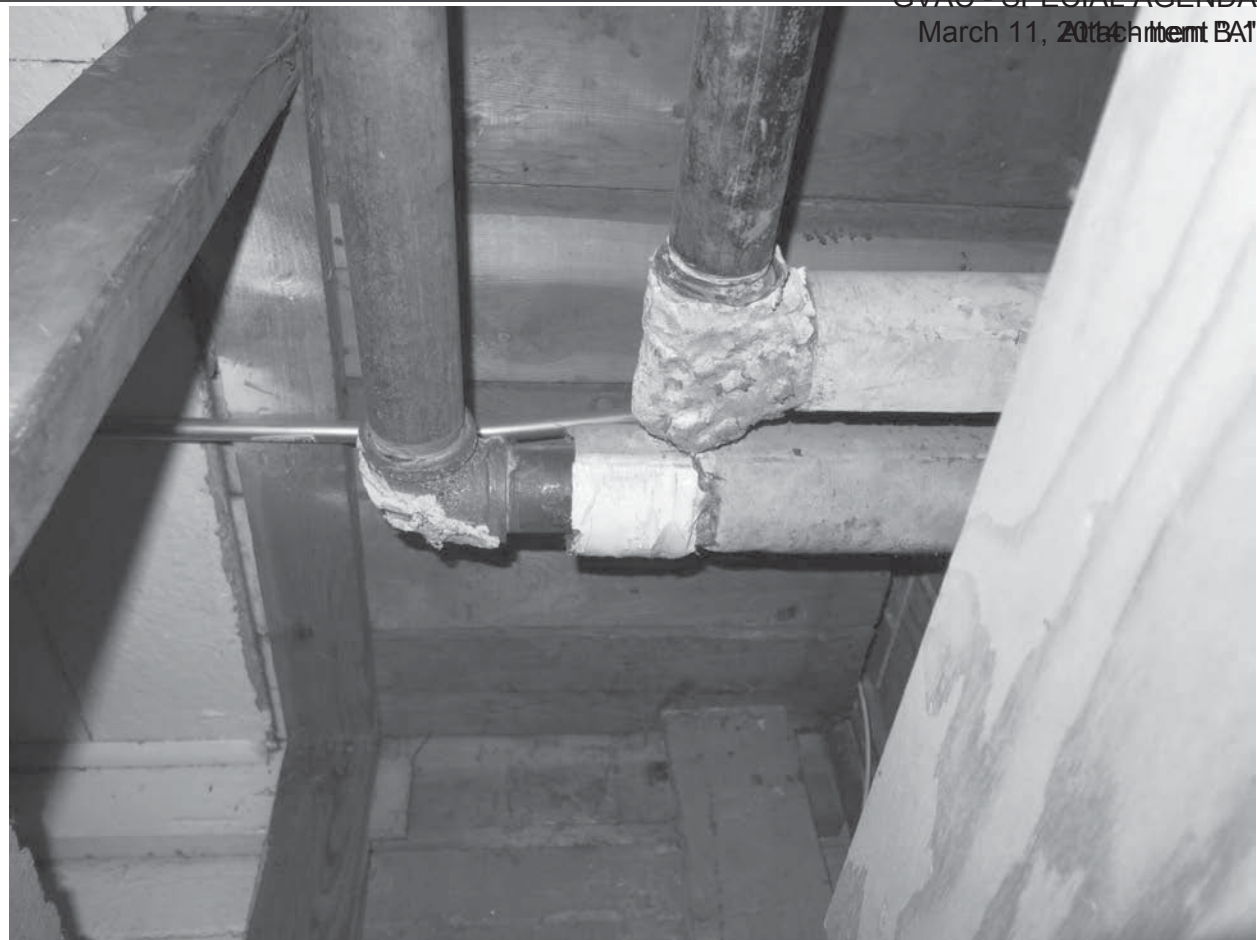
Picture No. 16: Good Condition Asbestos Insulating Cement (typical)
