REGIONAL DISTRICT OF NORTH OKANAGAN

CIVIC ARENA ENGINEERING ASSESSMENT

FINAL REPORT

Revised to 4 March 2014

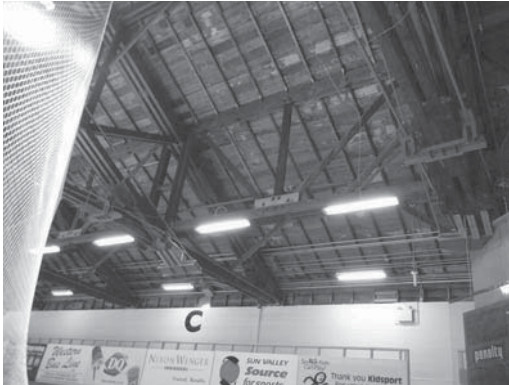
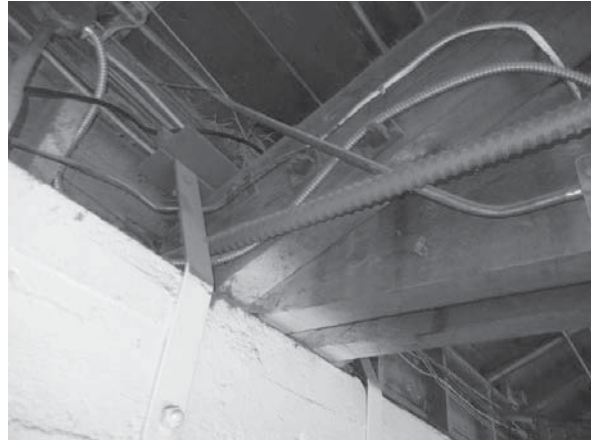
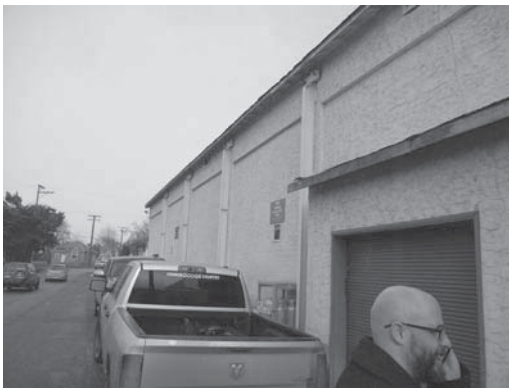
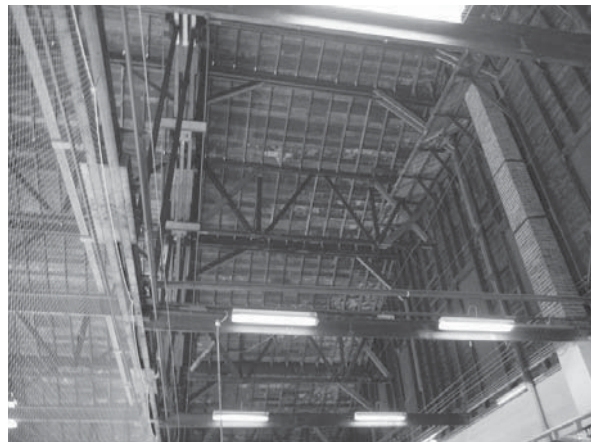
- The primary and secondary roof trusses and connections.
- Upgrading of the tension ties through addition of 35mm Dywidag tension rods to the timber tension ties.
- Provision of lateral bracing for end walls.
- The heel connection between the roof trusses and the concrete bearing wall.
- Addition (1996) of steel strong-backs to the wall pilasters supporting the roof trusses.

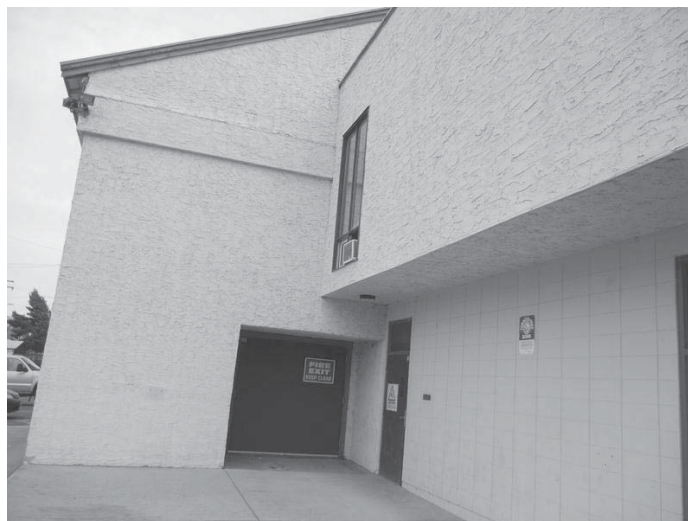
The 1988 study by Associated Engineering Ltd. Identified that roof joists and their wall connections for the northern addition are inadequate for the for the design snow loads.

The southern 1979 addition appears to be in good condition. There is no significant differential settlement or wall cracking visible. There is also no visible sign of rot or distress in the wood frame walls, roof or floor.

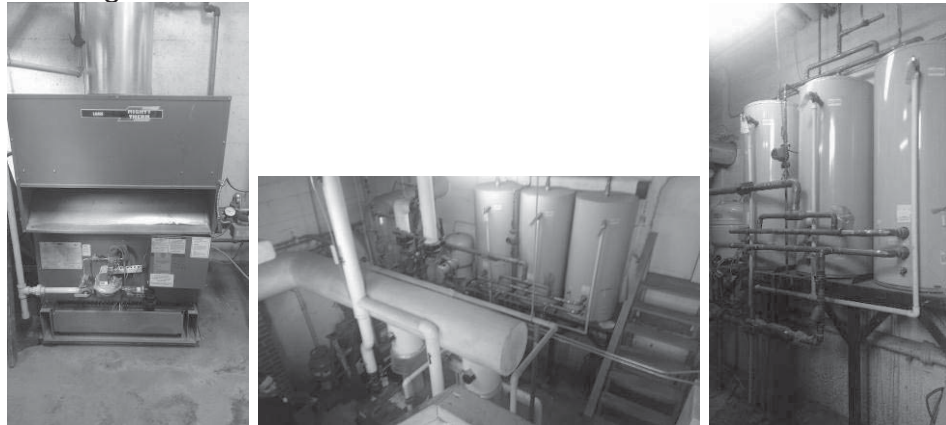
- Water entry is on North end of the building into the Mechanical room. Cross contamination certification up to date.
- Domestic Hot Water by gas boiler with three storage tanks for the two dressing rooms and washroom groups at the north of the original arena

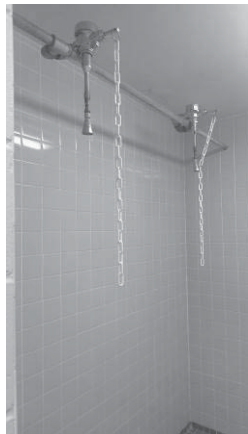
- Galvanized pipe used throughout facility
- Custom fixtures used

Low flow plumbing fixtures and insulation can help reduce domestic hot water loads/consumption. A review of the recirculation design should be completed and options to shorten dead-leg lengths thereby reducing the risk of standing water at dangerous temperatures. If a renovation of the facility is planned then contingency for a full upgrade to the plumbing system up to current code requirements will be required. Combining this work with the HVAC upgrades that would be required would lower the cost of mobilization estimated within each line item. The cost estimates are very rough ranges based on a visual inspection of the facility and its equipment and all presented costs should be confirmed by a cost consultant.

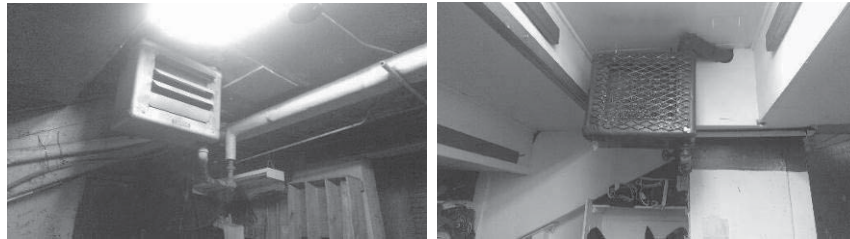
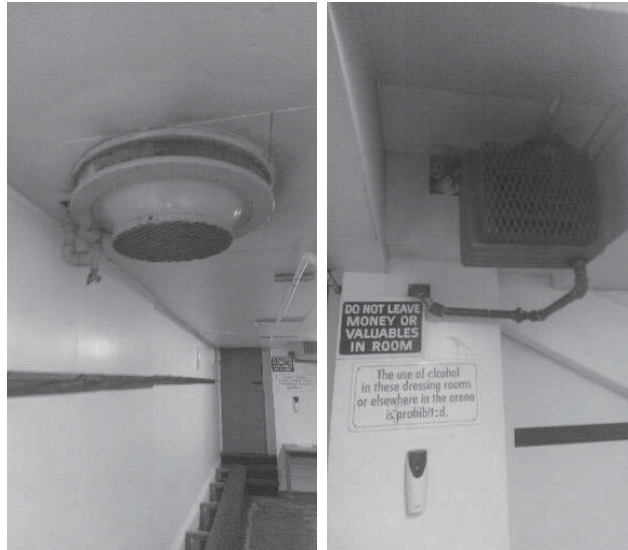
- Boiler 1
 - Burnham K808NEI-L20
 - 462 MBTUH in / 369 MBTUH out = 80%
 - Manufactured in 11/2000
- Boiler 2
 - Burnham P808NEI-L20
 - 462 MBTUH in / 369 MBTUH out = 80%
 - Manufactured in 03/1999
- Hydronic force flow units

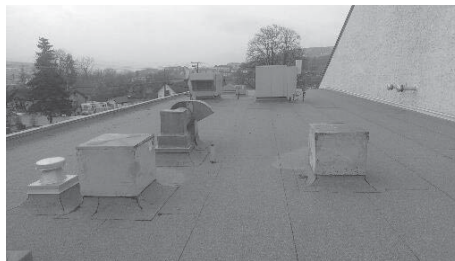
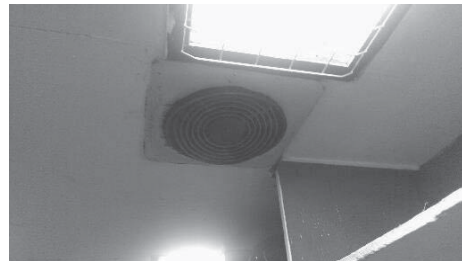
- Natural ventilation through roof hoods over the ice
- Washrooms and dressing rooms have independent exhaust fans

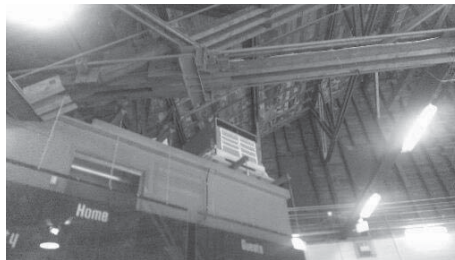
- De-humidification is supplied by two units at the northwest and southwest corners

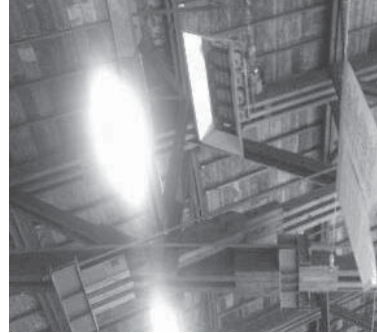
- Direct combustion power vented gas-fired tube heaters and gas-fired radiant ceramic panels have been added for the stands

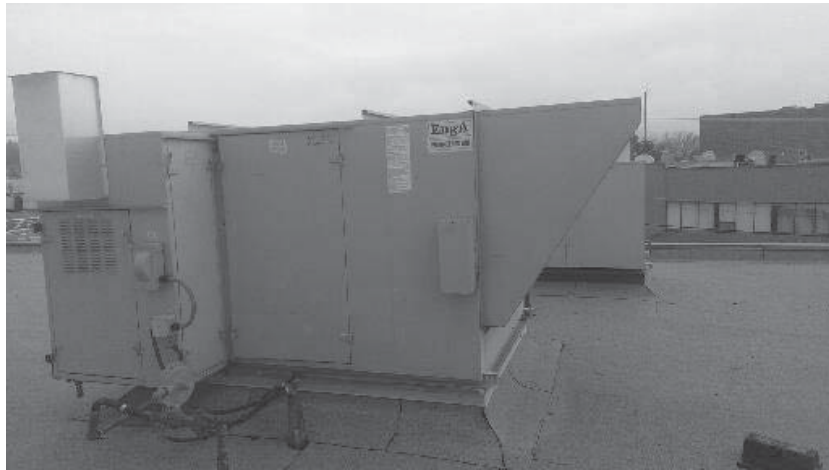
- Vestibules have electric force flow heaters in the south addition
- The south addition has an Eng. Air DJ40 MUA unit that serves the second floor.

- This unit was manufactured in 2005.
- Indirect gas fired modulating burner
- 400MBTUH in / 312MBTUH out 78% efficiency
- The south addition has an Eng. Air DJ20 unit that serves first floor and the upstairs opening to the lobby below.

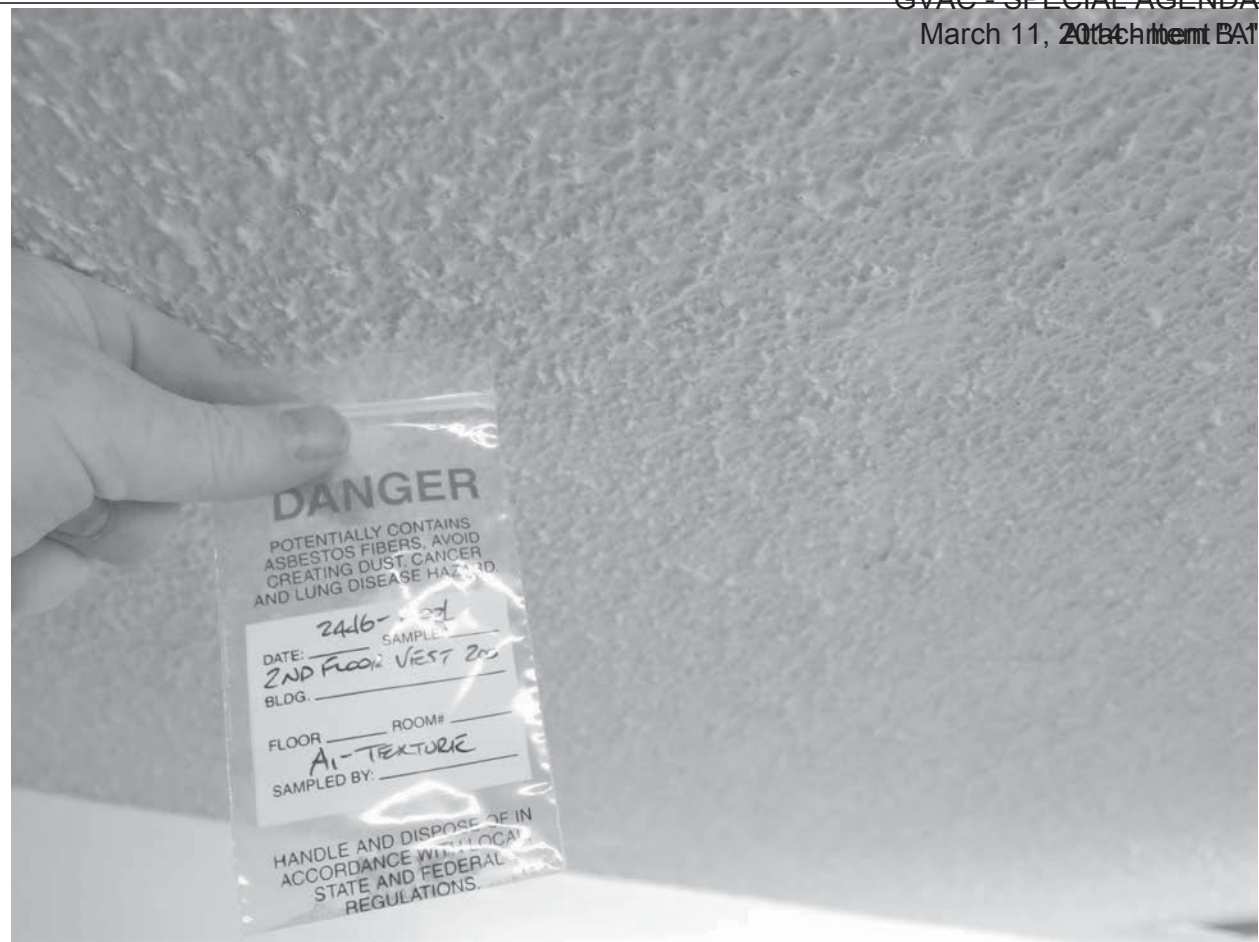
Picture No. 2: Sample 2 – (P1) Asbestos Drywall Tape Compound (typical)

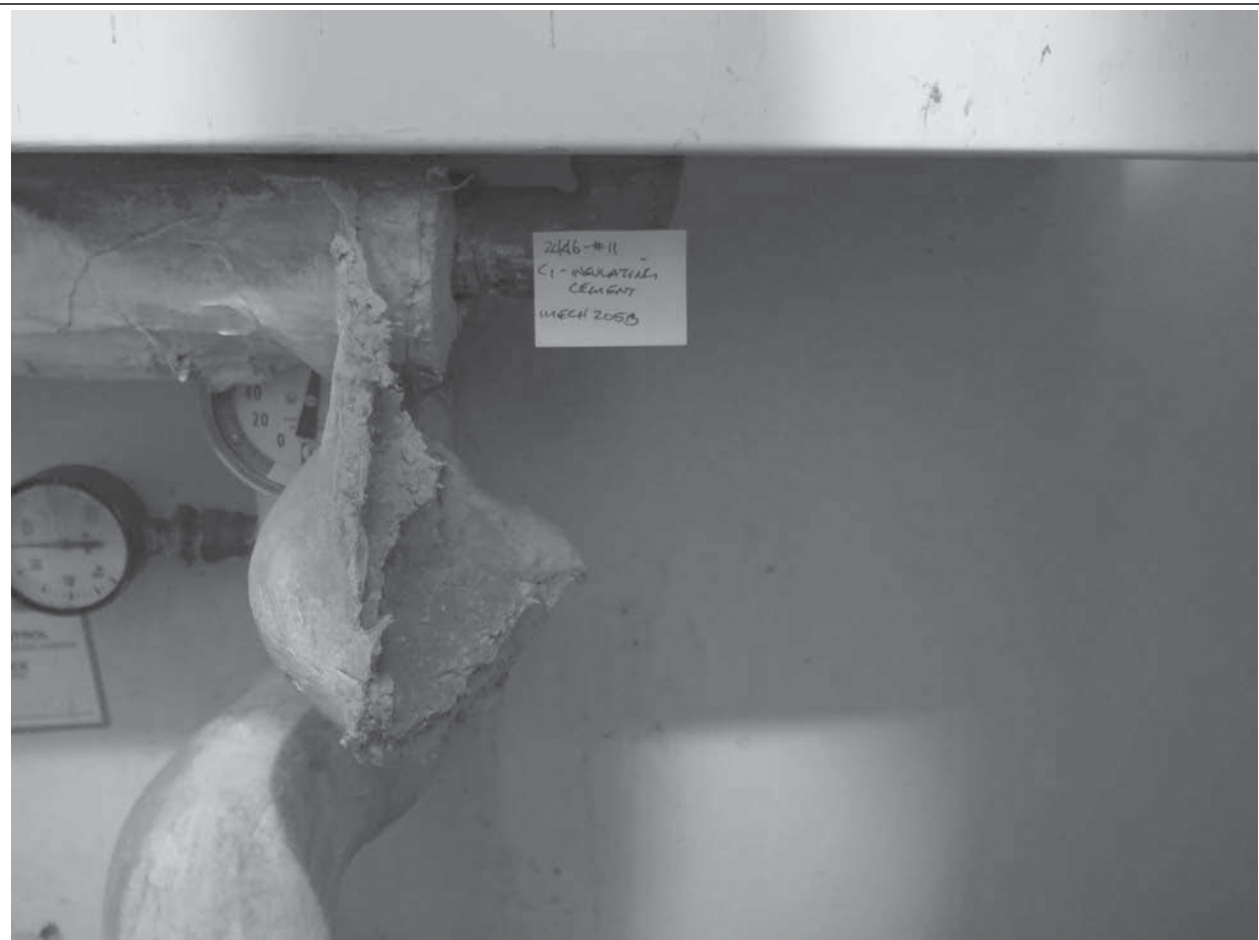
Picture No. 7: Sample 9 – Non Asbestos Floor Tile
